**WTA Lynden Station**  
 1945 Front Street, Lynden WA, 98264  
 Whatcom Transit Authority

Job No:	2312	Date:	30 JAN. 2024
File No:			
Drawn By:	KMG		
Checked By:	JM		
Issued For:	MASTER PLANNING

MASTER PLAN  
 PHASE 1  
**A110**

We are pleased to submit four copies of our report entitled "Environmental Site Assessment, and Preliminary Geotechnical Engineering Services, Proposed Lynden Transfer Center/Park & Ride Site, Lynden, Washington." Our services were completed in general accordance with our proposal dated May 29, 1996 with subsequent modifications because of environmental conditions encountered at the site.

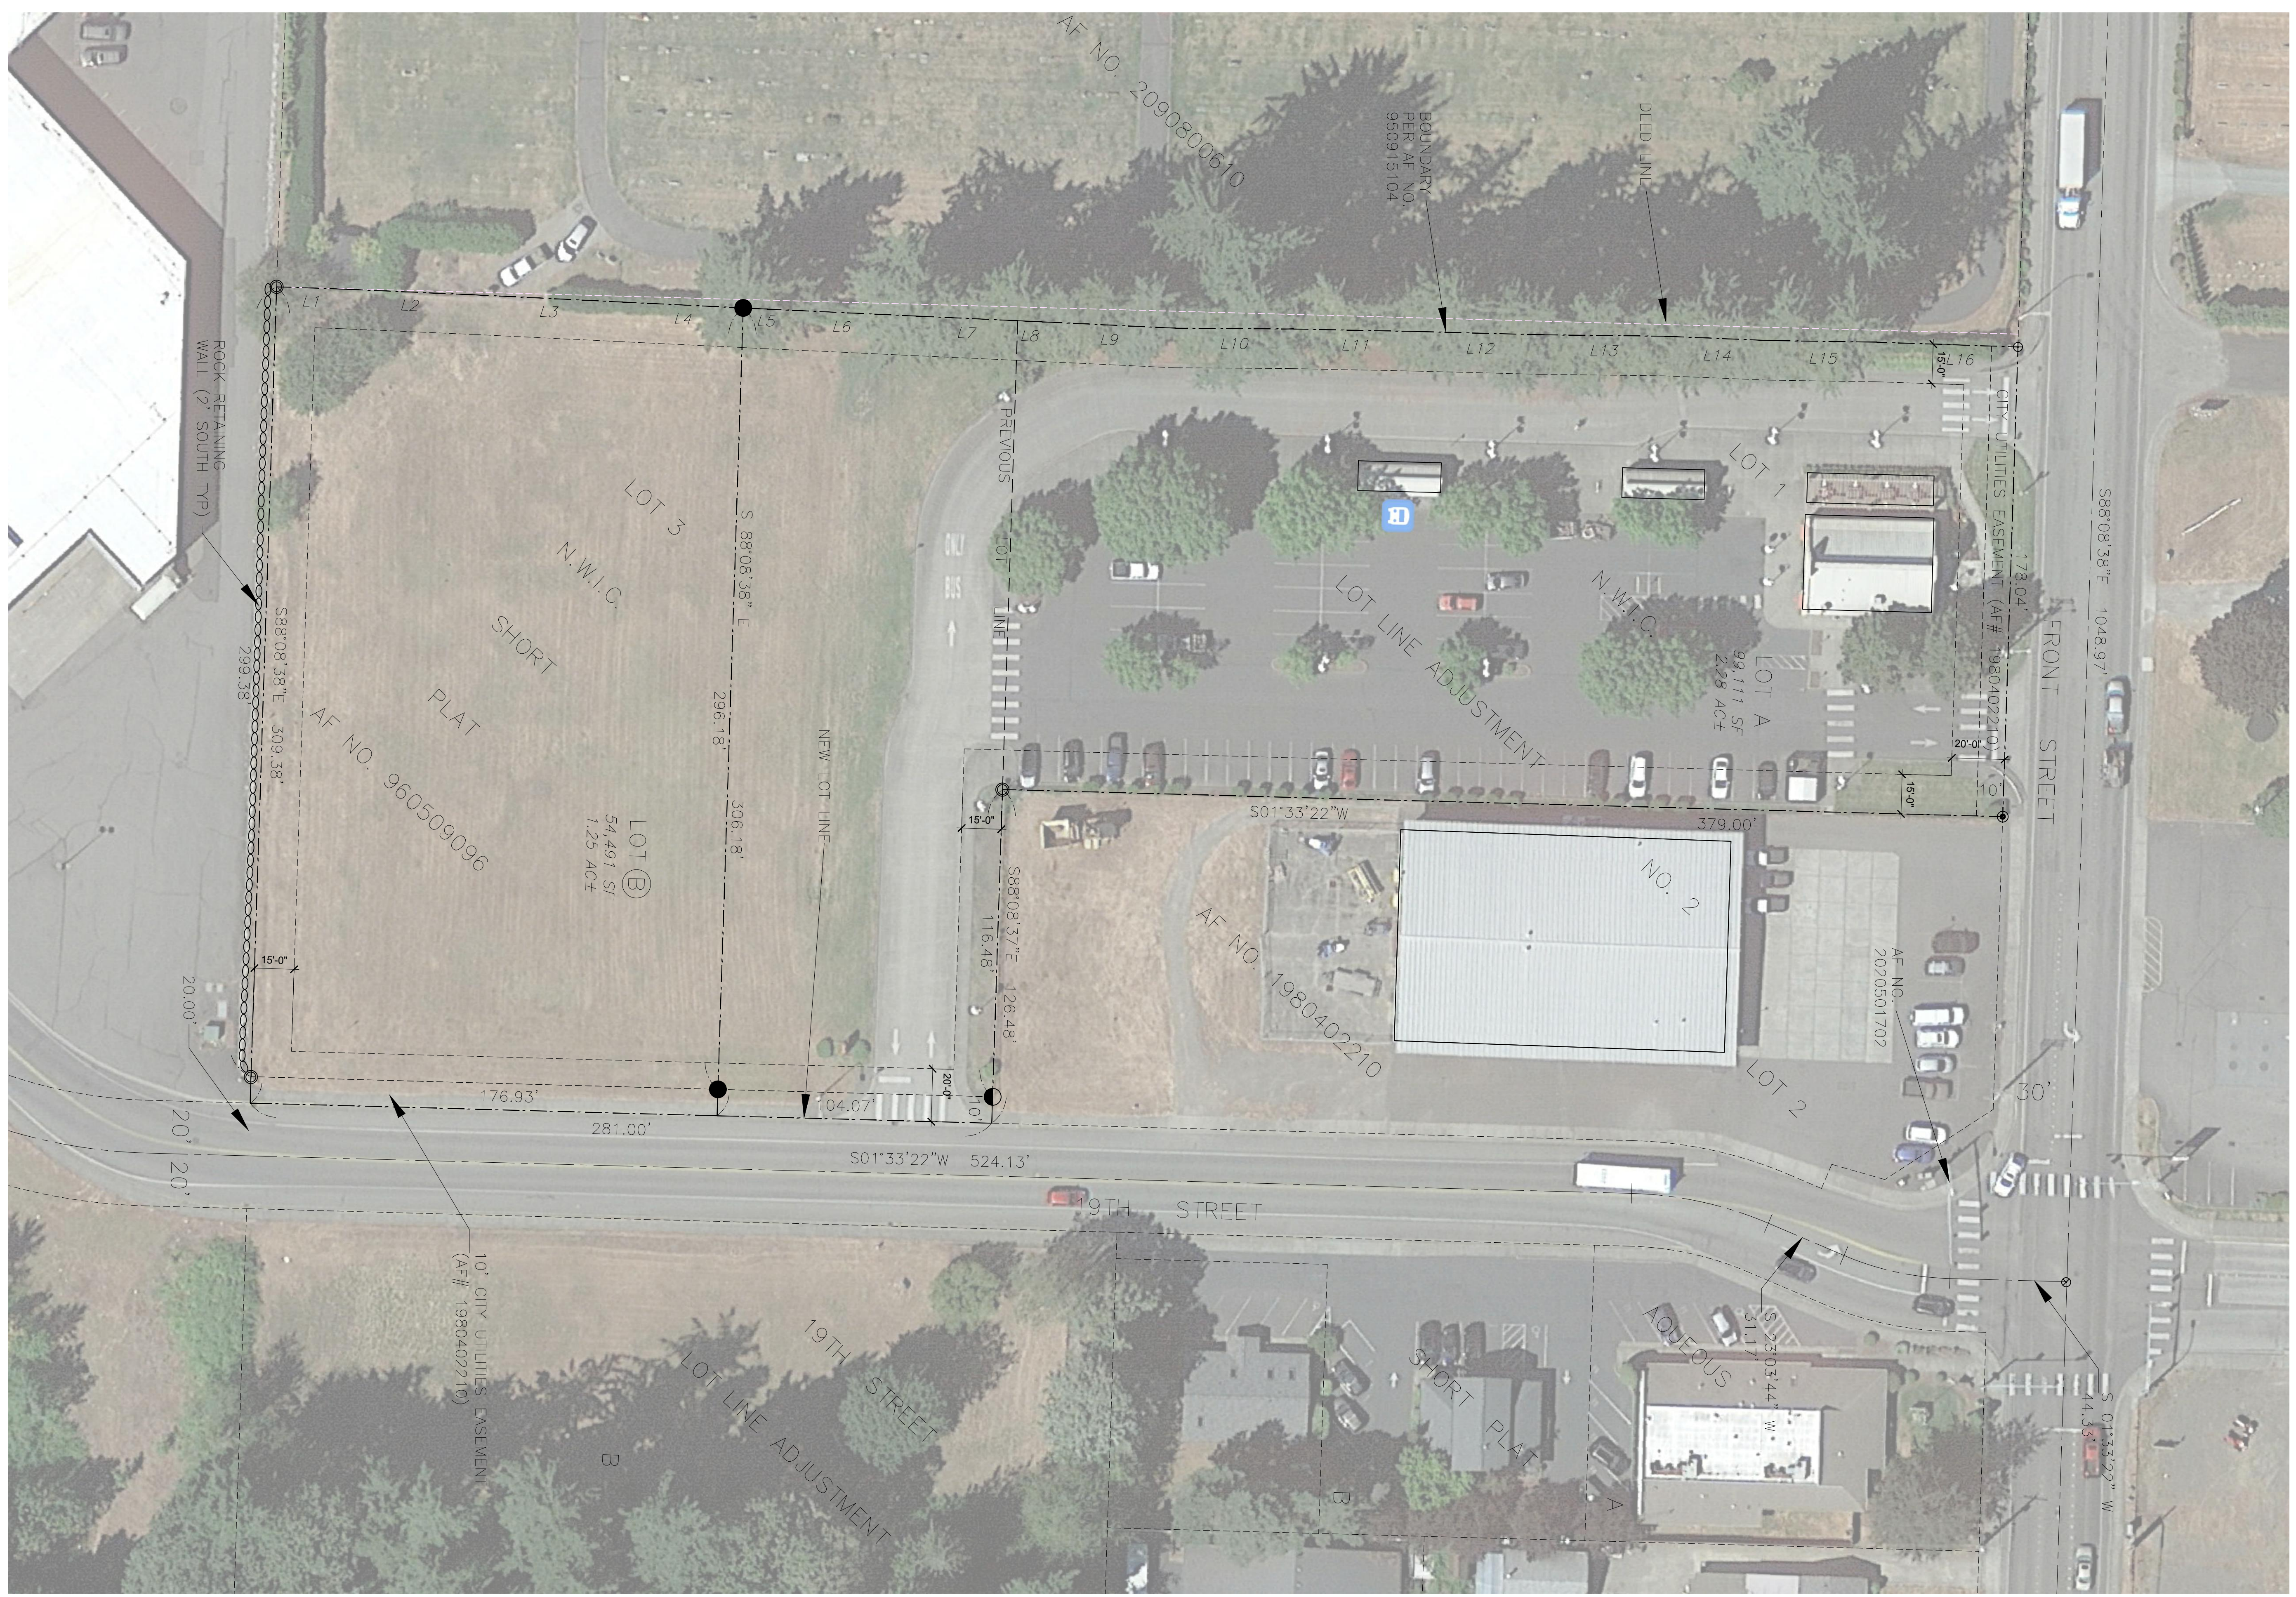
**1** EXISTING CONDITIONS SITE PLAN  
SCALE: 1" = 30'-0"

EXISTING  
CONDITIONS  
SITE PLAN

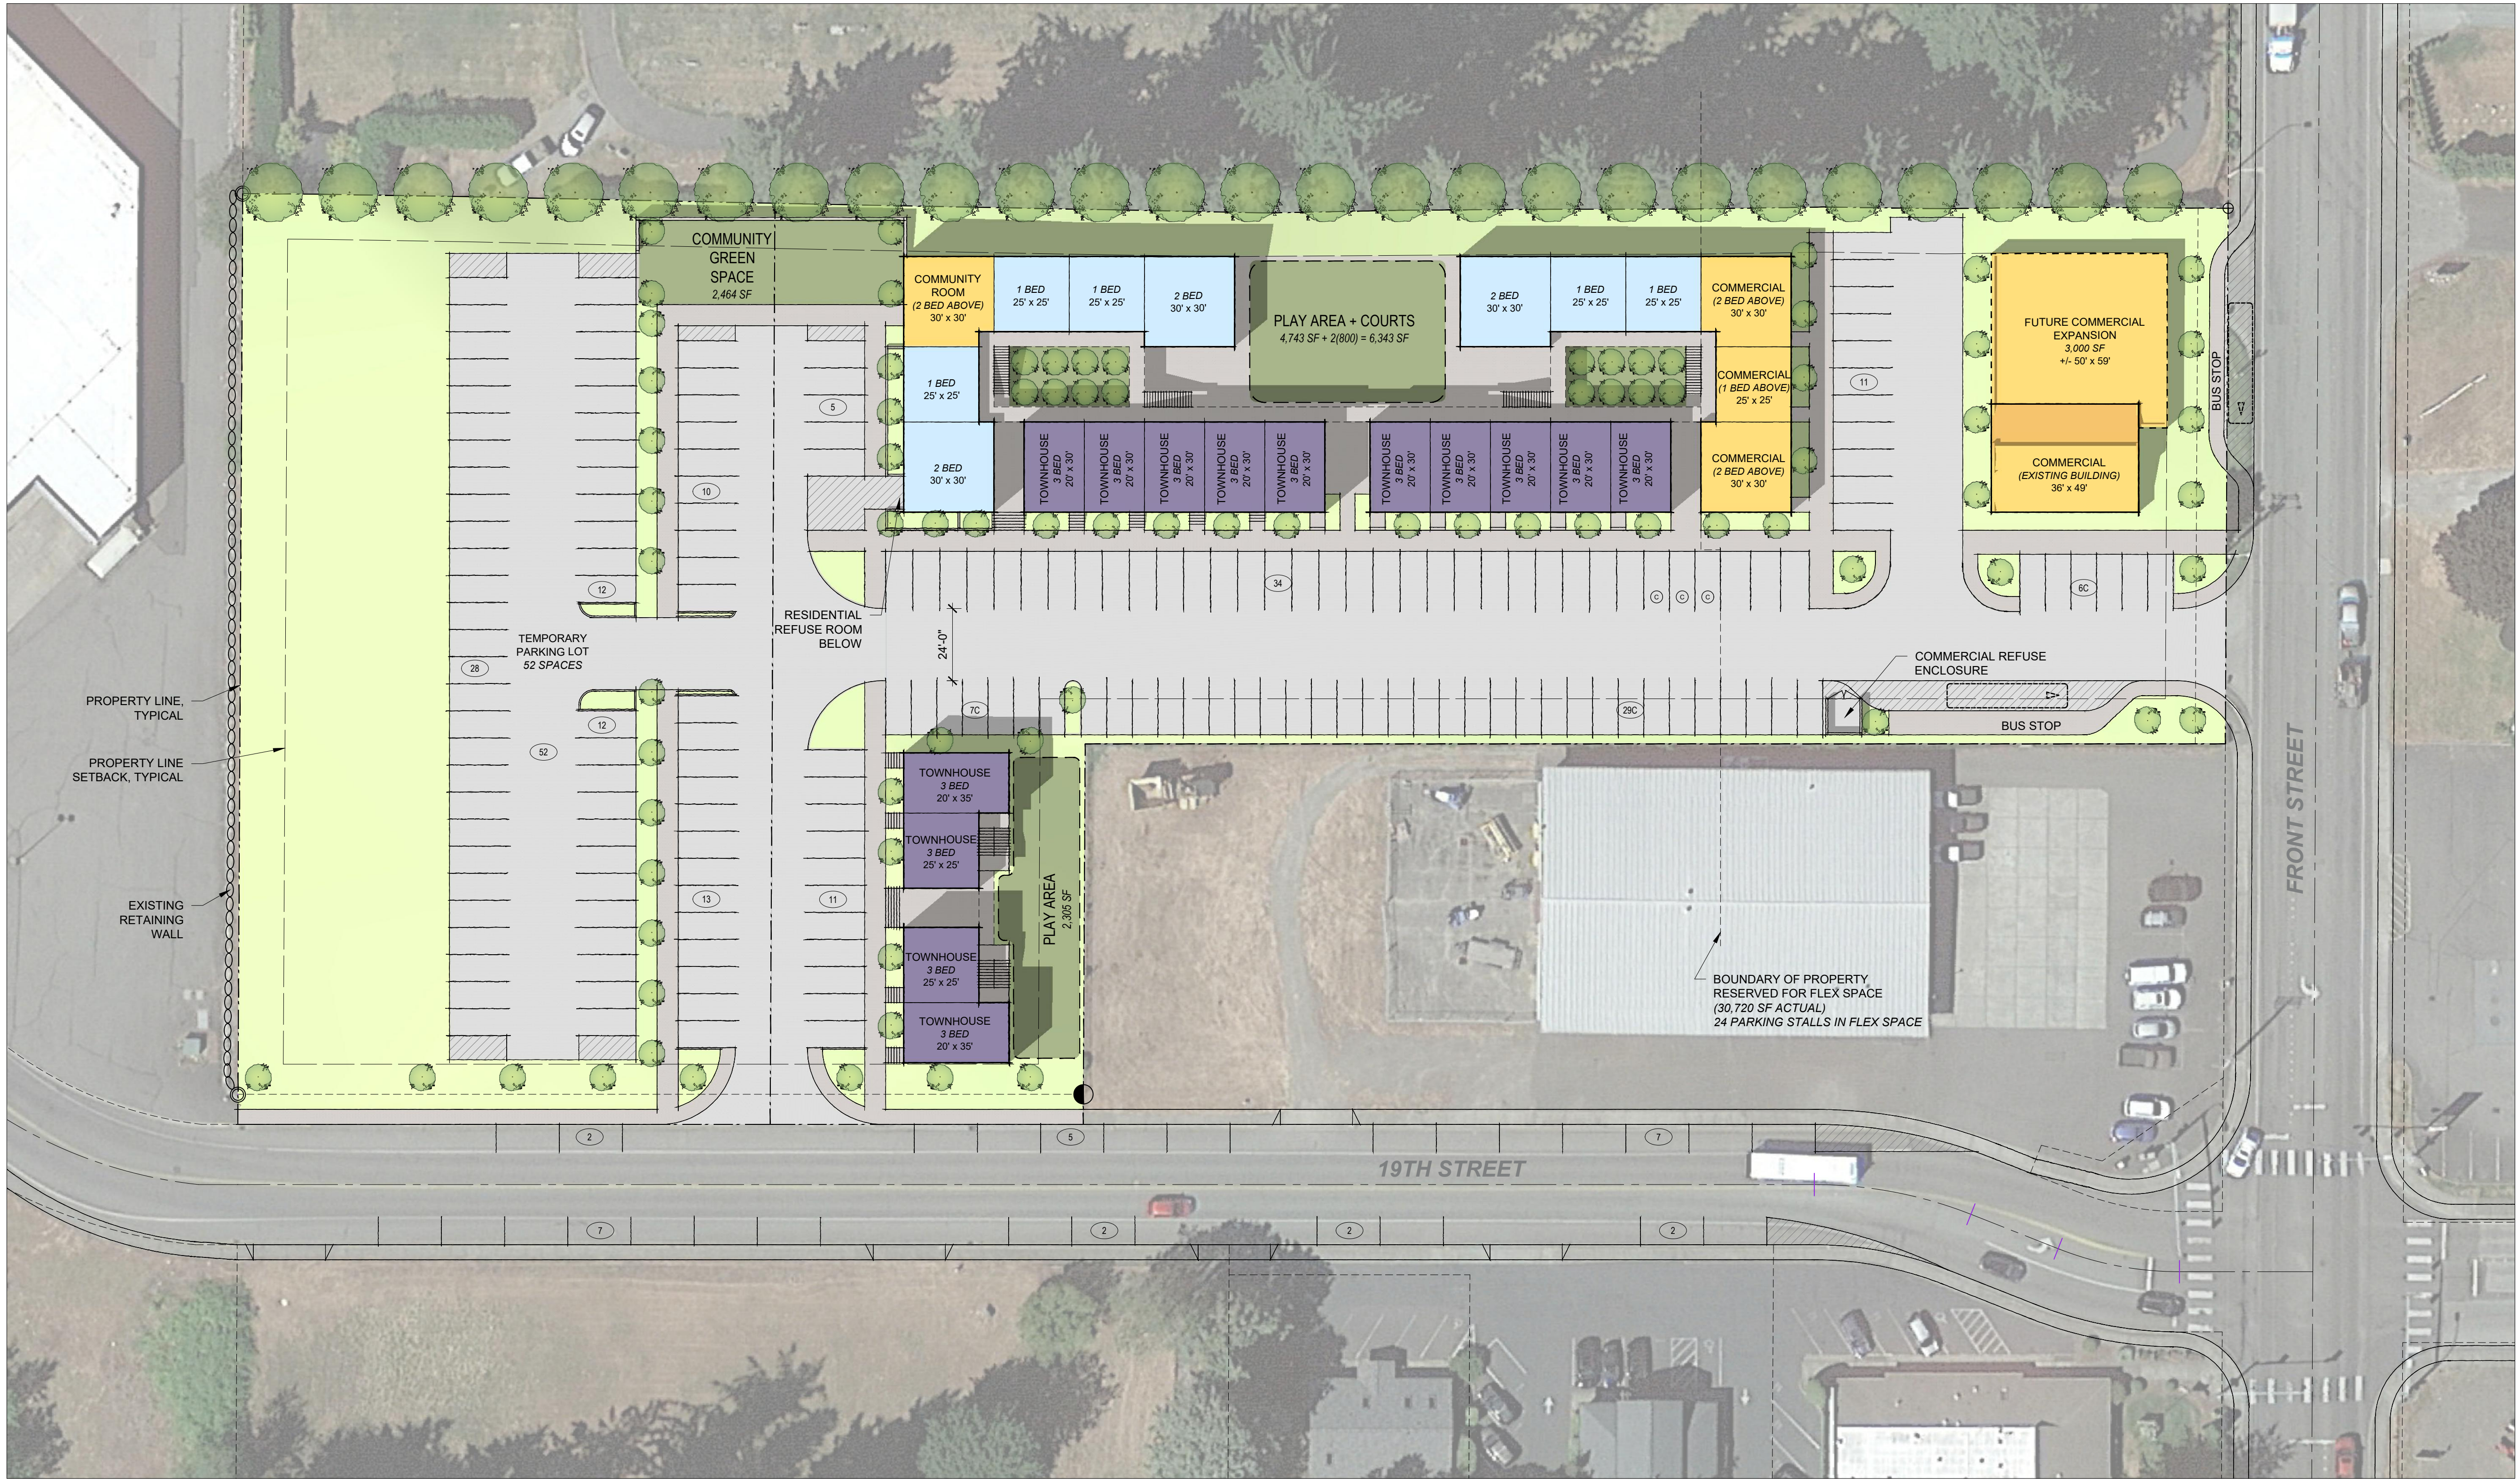
**1 MASTER PLAN - PHASE 1**

**PARKING CALCS PER LYNDEN MUNICIPAL CODE**

<b>RESIDENTIAL PHASE 1:</b>			
3-BEDROOM TOWNHOUSE	28 UNITS	X3	= 84 STALLS
2-BEDROOM UNIT	15 UNITS	X2	= 30 STALLS
1-BEDROOM UNIT	17 UNITS	X2	= 34 STALLS
<b>SUBTOTAL</b>	<b>60 UNITS</b>		<b>= 148 STALLS</b>
<b>TOTAL COMMERCIAL:</b>			
OFFICES	3,300 SF / 250		= 13.2 STALLS
DAYCARE	1,700 SF / 250		= 6.8 STALLS
ADDITION	3,000 SF / 250		= 12.0 STALLS
<b>SUBTOTAL</b>	<b>8,000 SF = 32 STALLS - 25%</b>		<b>= 24 STALLS</b>
<b>TOTAL ADA STALLS:</b>			
COMMERCIAL	(IBC 1106.1)		= 1 STALLS
RESIDENTIAL	2% OF STALLS (IBC 1106.2)		= 3 STALLS
<b>SUBTOTAL</b>			<b>= 4 STALLS</b>
<b>PROJECT TOTAL = 148 + 24 + 4 = 176 STALLS REQUIRED</b>

**ACTUAL PARKING PROVIDED**

PERMANENT SURFACE PARKING: 126 STALLS  
 OVERFLOW SURFACE PARKING: 52 STALLS  
 TOTAL = 178 STALLS (45 COMPACT PROVIDED, 53 COMPACT ALLOWED)

**STREET PARKING ON 19TH**

4(2) + 2(7) + 5 = 27 TOTAL STREET STALLS FEASIBLE
